WORKER RIGHTS CONSORTIUM

**WORKER RIGHTS CONSORTIUM ASSESSMENT
ITIC APPAREL (DOMINICAN REPUBLIC)
FINDINGS AND RECOMMENDATIONS**

February 8, 2012

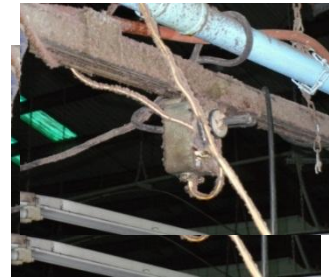
- Also in Building One, there is an overhead outlet box with open contacts that are exposed. Romex wiring was used inappropriately here. There is also an accumulation of combustible cloth fiber on an energized outlet.

- Review all electrical installations in Buildings One and Two and make repairs to the violations noted above and to any other electrical connections that do not meet Dominican legal standards.
- Develop and implement a lockout/tag-out system for the plant and train maintenance personnel on these procedures.
- Discontinue use of the elevator in Building One until such time as the manufacturer provides information about the safety of using the winch for this purpose. This information should be provided to the WRC once it has been obtained. If it is determined that the winch can safely operate the elevator, then the capacity rate for the winch-operated elevator should be visibly posted at the elevator.

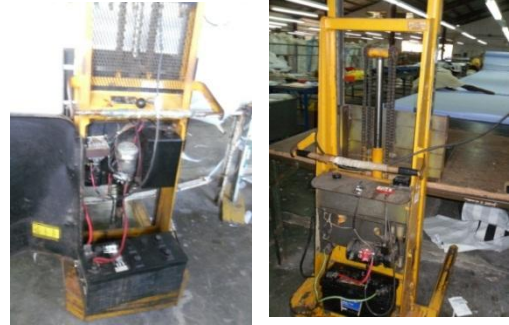
- In Building Two, the forklifts used for carrying cloth rolls have open, exposed and/or energized electrical equipment. There are oversized battery blocks on the hinged panel door of one forklift and on the other forklift the panel has been removed altogether.
